ALASKA GEOBOTANY  
CENTER DATA REPORT

**AGC 23-01**

# PERMAFROST & REMOTE SENSING STUDIES: 2022 FIELD REPORT FOR POINT LAY, ALASKA

JANUARY 2023

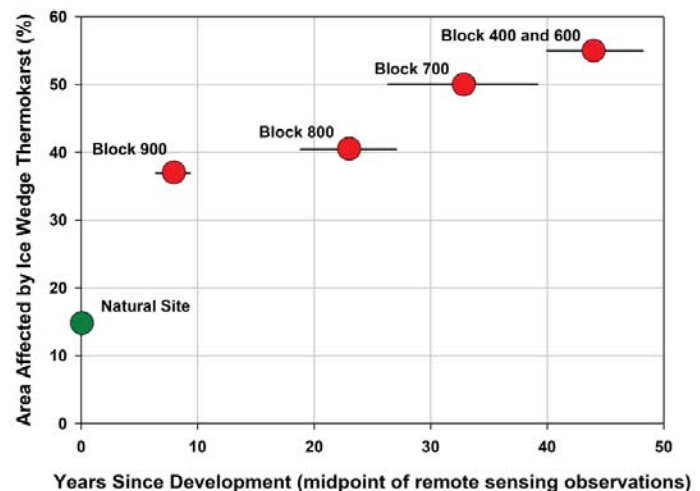
Figure 3. Area of ice wedge thermokarst in relation to years since development using the drone data. (Credit: B.M. Jones)

As infrastructure ages, the area affected by ice wedge thermokarst increases in a relatively linear fashion due to an increase in mean annual surface temperature (MAST) and active-layer thickness due to multiple processes related to the presence of infrastructure:

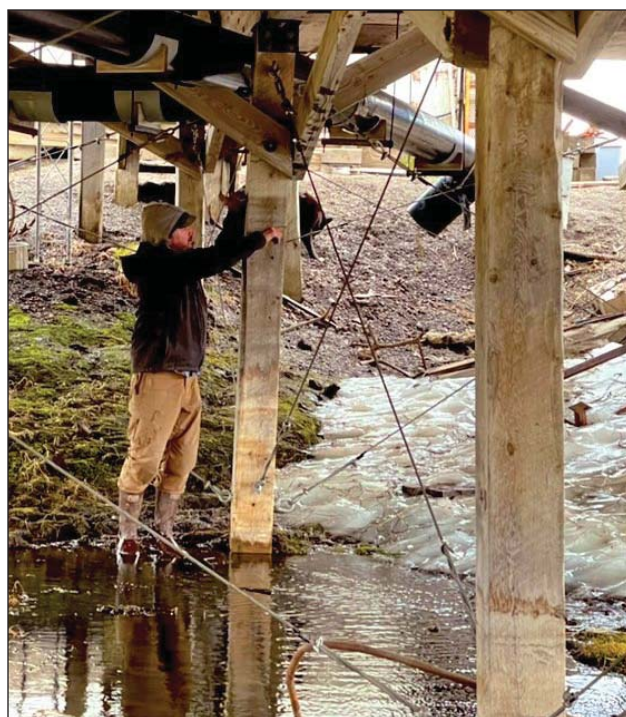
**Figure 5.** Assessing subsidence below homes in Point Lay. Melting ice wedges below this home have resulted in nearly 2 m (6.5 ft) of subsidence leaving only about 1 m (3.2 ft) of pile embedment. (Credit: P. Bolz)

Based on our investigation, most of the piling beneath village housing was originally embedded 3 m (10 ft). It appears that those piles embedded in ice wedges have as little as 1 m (3.2 ft) of embedment remaining (Figure 5). Those piling founded in the ice-rich permafrost soils are embedded between 1.2 and 1.8 m (4 to 6 ft). Based on the drone data and ground-survey photos taken of house foundations, we estimate about 30% of the residential piles in the village are founded in ice wedges.

- We estimate about 30% of the residential piles in the village are founded in ice wedges.
- If a structure is founded on both ice wedges and ice-rich soils, troughs form over the ice wedges, reducing the embedment of piles founded in wedges. (Areas of ice-rich permafrost will subside, but to a lesser extent.) In cases where all piles are founded within ice wedges, ponding forms under the entire structure. In both cases, the embedment of the piling is significantly reduced (Figure 4).
- Most of the piling beneath village housing was originally embedded 10 feet. Those piling founded in the ice-rich permafrost are embedded between 4 and 6 feet. It appears that those piles embedded in ice wedges have as little as 3 feet of embedment remaining (Figure 5).

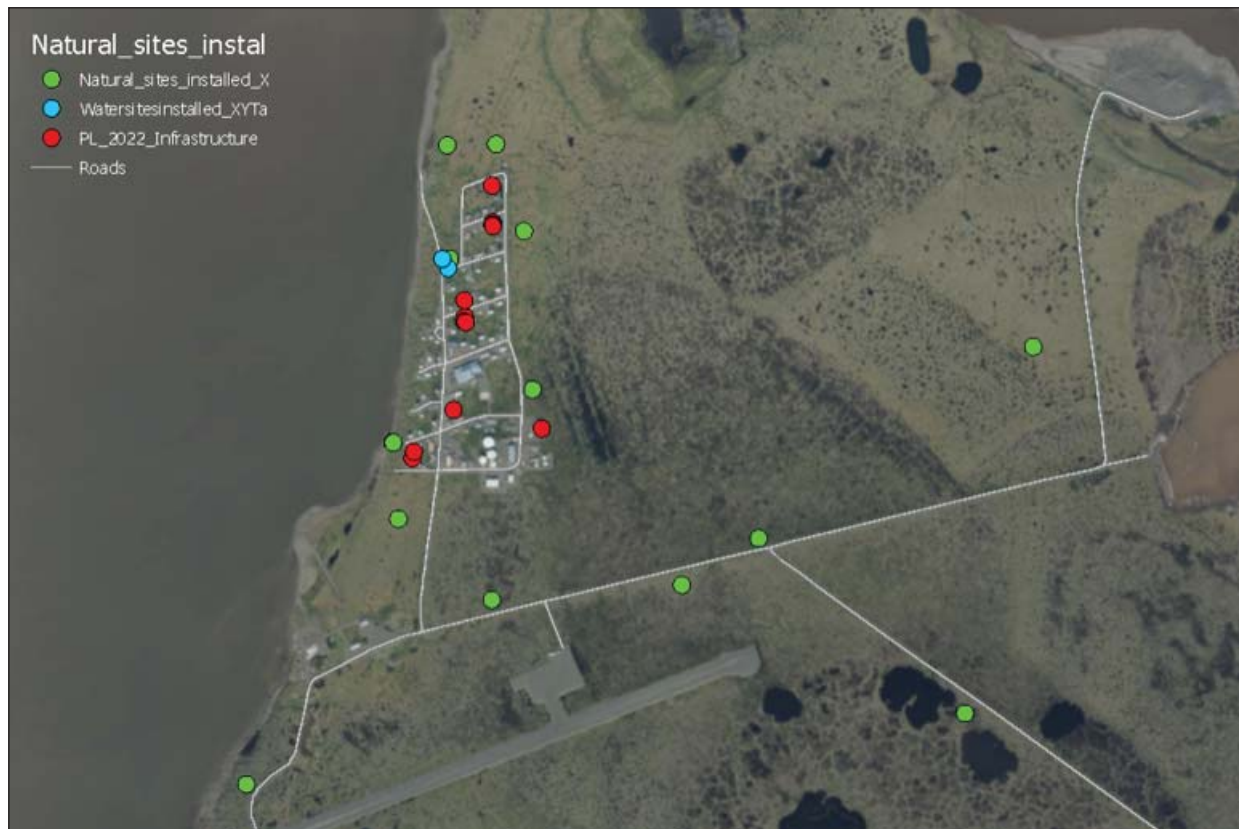
**Figure 9.** Map showing locations of permafrost temperature sensors installed in natural (green dots) and infrastructure sites (red dots). Water depth sensors were also installed in several locations (blue dots).

monitoring stations in 14 natural sites and 13 infrastructure sites in Point Lay (Figure 9).

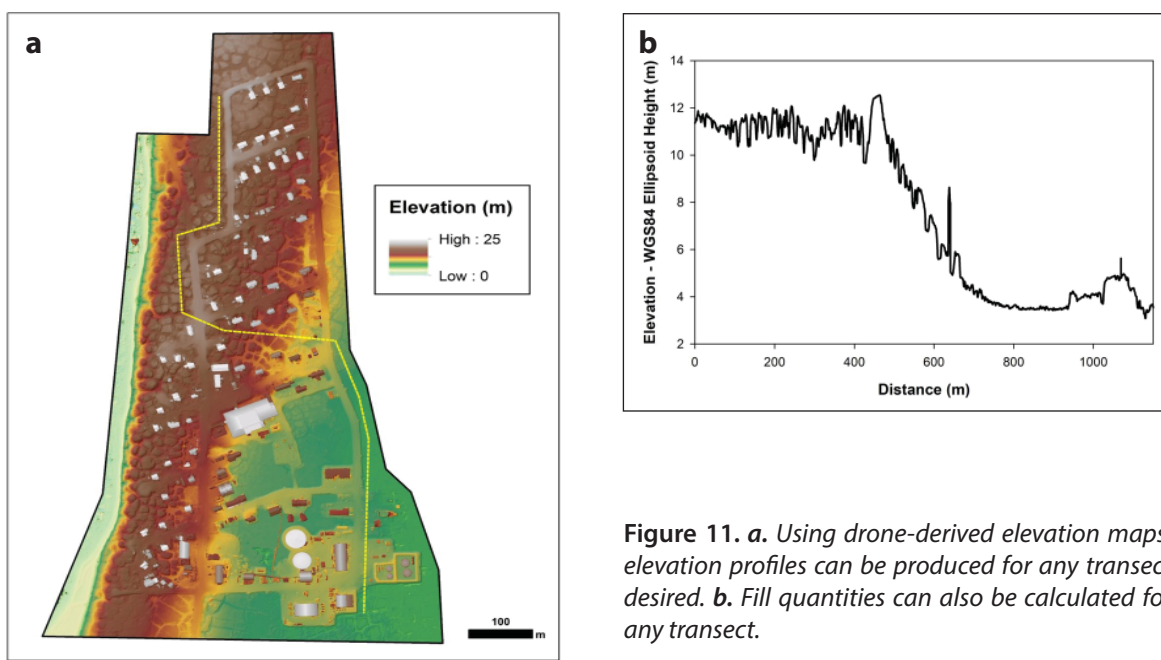
**Figure 11.** *a. Using drone-derived elevation maps, elevation profiles can be produced for any transect desired. b. Fill quantities can also be calculated for any transect.*

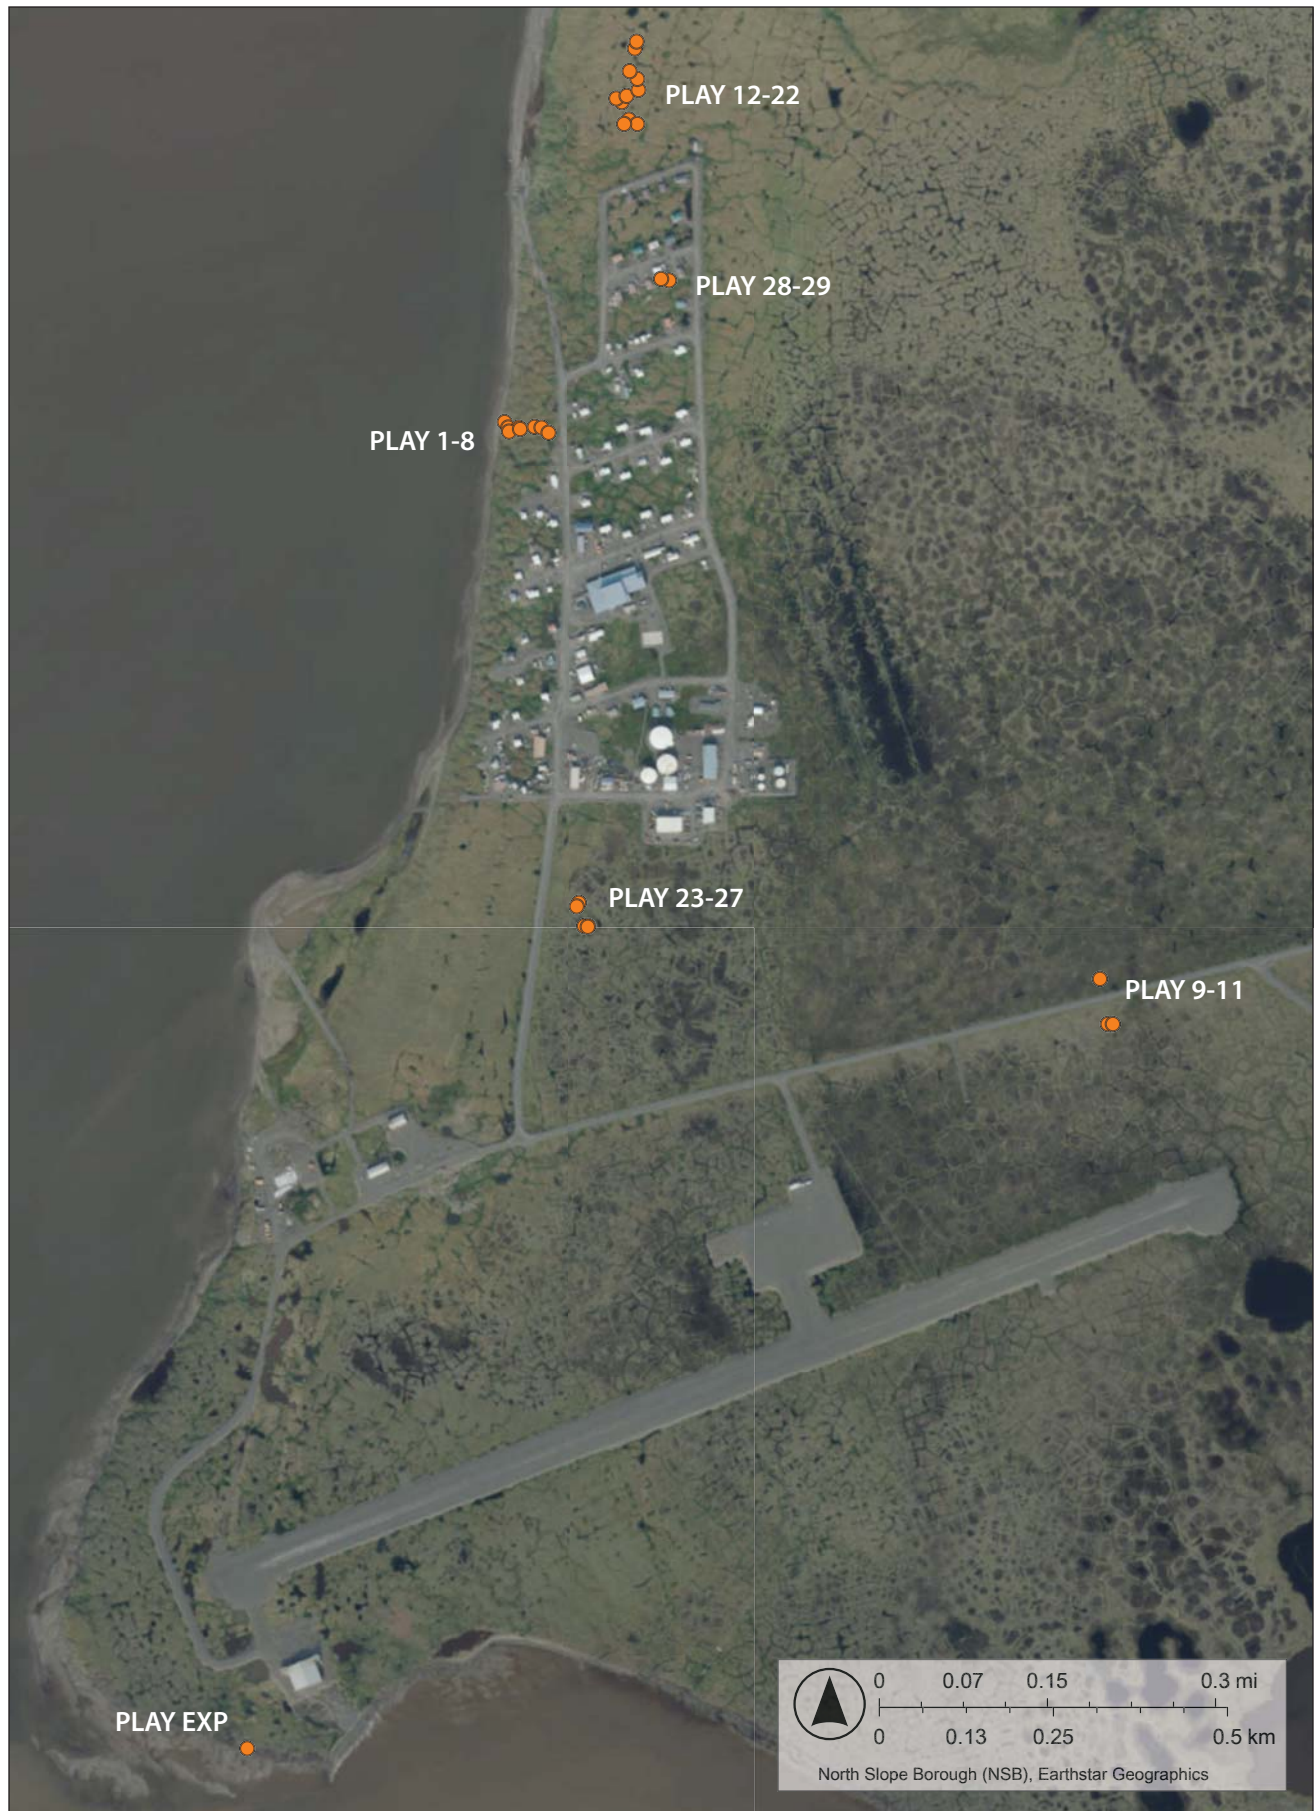
**Figure A1.2.** Boreholes PLAY-1 to 8 were drilled to the west of the townsite (near the 600 block) on the yedoma slope terrain along the coast on 26 June 2022. (See Figure A1.1 for general location map.)

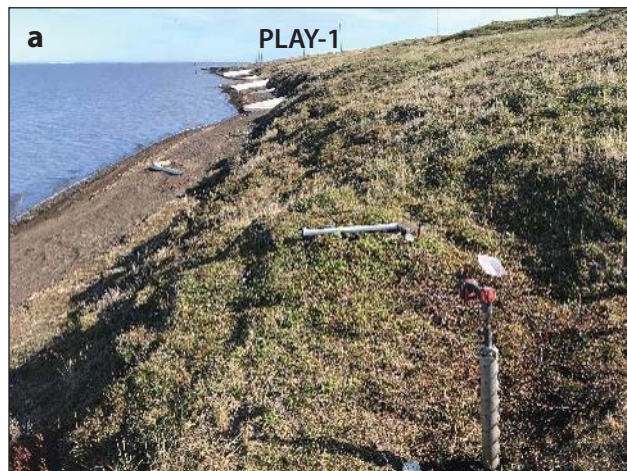
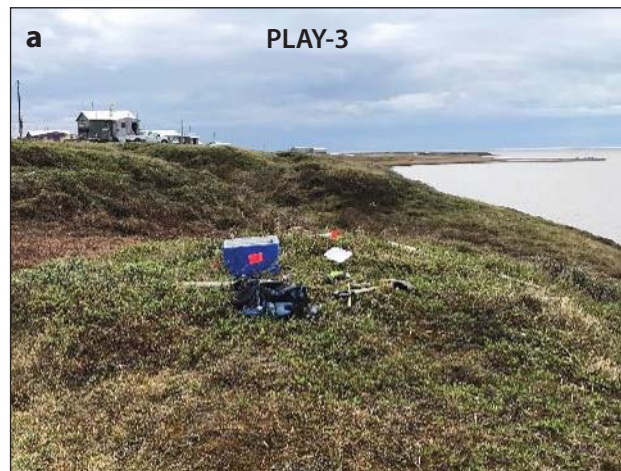
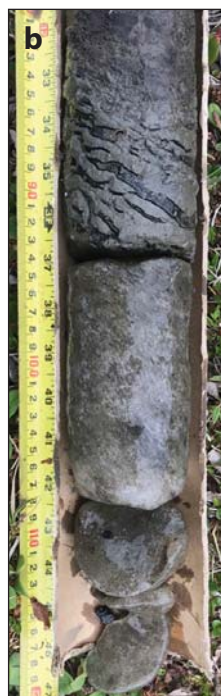
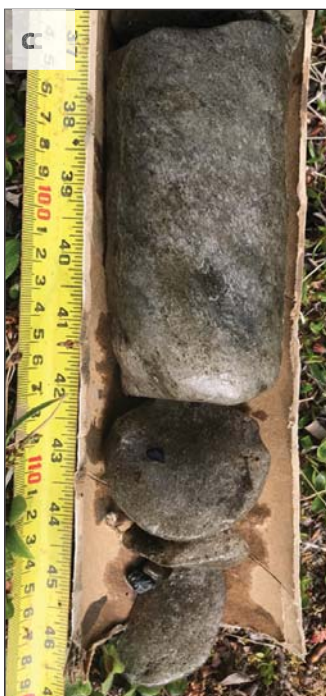
**Figure A1.3 a.** Borehole PLAY-1, elevation 3.1 m above sea level (a.s.l.), was drilled with the 3-inch diameter SIPRE corer in an ice-wedge trough. **b-c.** Photographs of the frozen core. At left (**b**), the protective intermediate layer of the upper permafrost (depth 76-93 cm) above the ice wedge is shown. Note inclined soil layers and ice lenses above the ice wedge (**b**) and gravel inclusions in wedge ice from ~105 cm (**c**). (Credit: M. Kanevskiy)

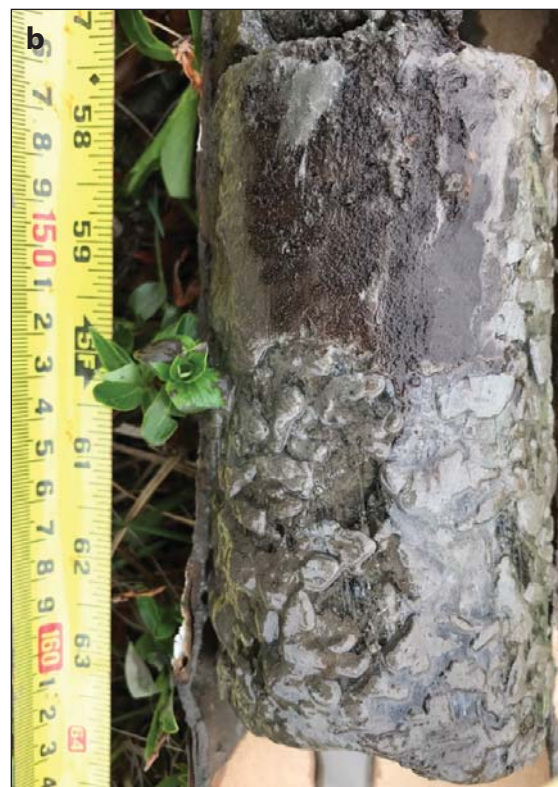
**Figure A1.4 a.** Borehole PLAY-3, elevation 9.2 m a.s.l., was drilled at the top of the baydzherakh (thermokarst mound). **b.** Analysis of the core at a depth of 147-161 cm shows an ice-rich sandy silt with vertically oriented peat inclusions and ataxitic cryostructure in silt. (Credit: M. Kanevskiy)

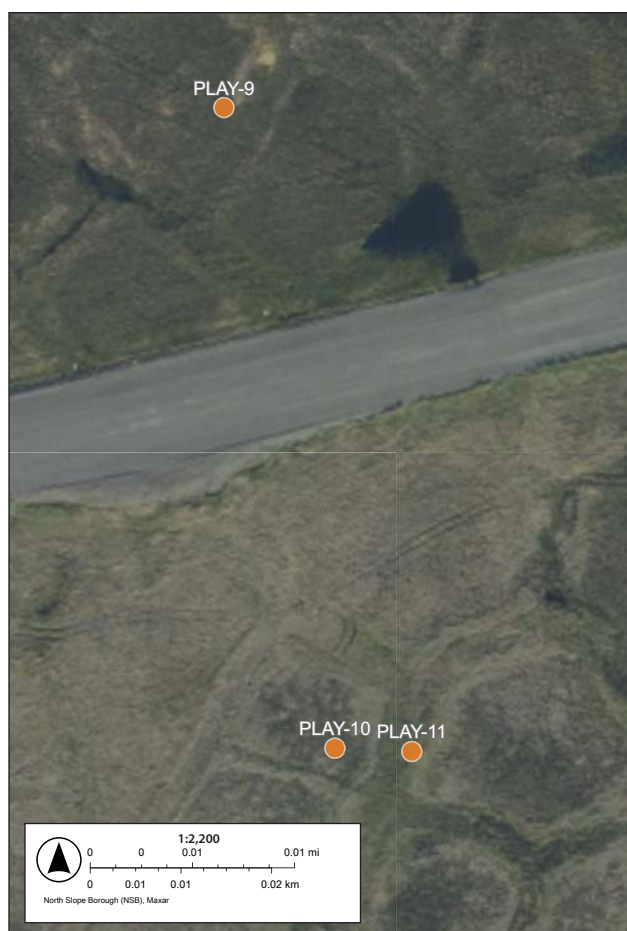
**Figure A1.5.** Boreholes PLAY-9 to 11 are in a large thaw lake basin along the Airport Road between the Airport Access Road and the Landfill Access Road. Borehole PLAY-9 and 10 were drilled from polygon centers. Borehole PLAY-11 was drilled from a thermokarst trough. All boreholes were drilled on 27 June 2022. (See Figure A1.1 for general location map.)

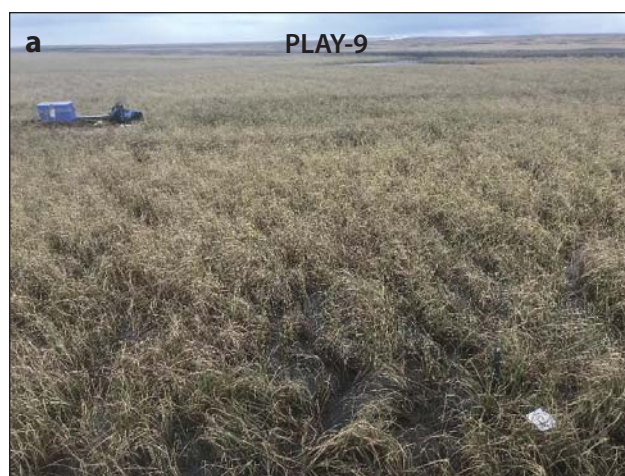
**Figure A1.6. a.** Borehole PLAY-9 was drilled with a SIPRE corer in a wet thaw lake basin, at 2.7 m a.s.l.. **b.** The permafrost core shows ice-rich sandy silt with ataxitic cryostructure from 122 to 141 cm beneath the surface. (Credit: M. Kanevskiy)

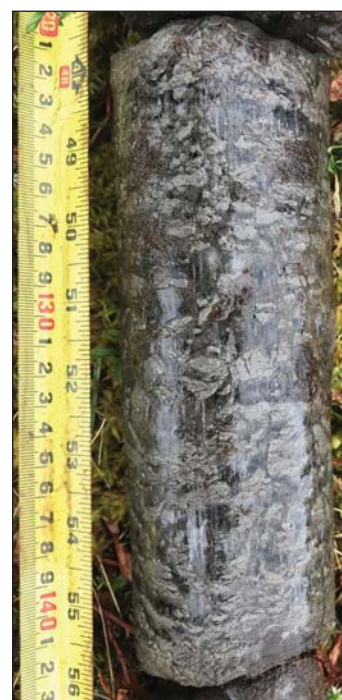
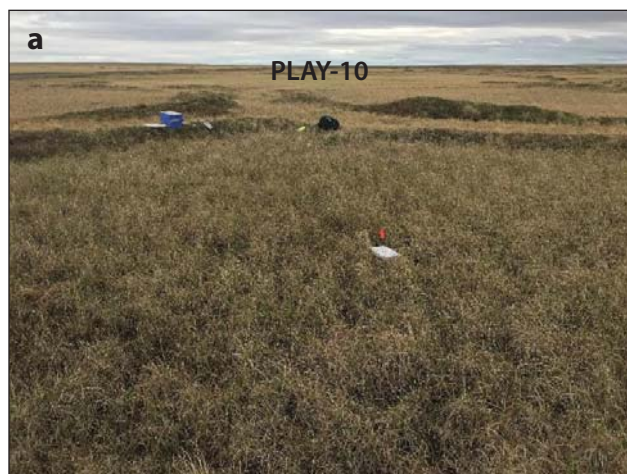
**Figure A1.7. a.** Borehole PLAY-10 was drilled with a SIPRE corer in a wet thaw lake basin with low-centered polygons, elevation 2.3 m a.s.l. **b.** Core shows ice-rich sandy silt with ataxitic cryostructure at depth of 104 to 117 cm. (Credit: M. Kanevskiy)

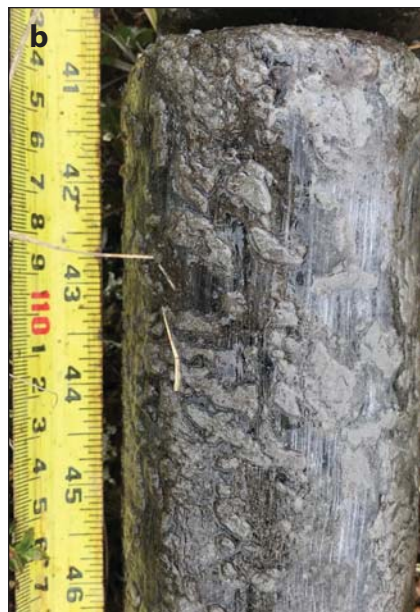
**Figure A1.8.** Boreholes PLAY-12 to 22 are located on yedoma terrain in the undeveloped area just north of the townsite townsite (boreholes PLAY-12 to PLAY-14 are not shown; they are located south of PLAY-15, see Figure A1.1 for general location map). Borehole PLAY-12 was drilled in a polygon center with a SIPRE corer to describe and sample frozen soils and ground ice. All other boreholes in this area were drilled in polygon troughs with a Kovacs auger to estimate the depth to wedge ice and vertical extent of ice wedges. All boreholes were drilled on 27 June 2022.

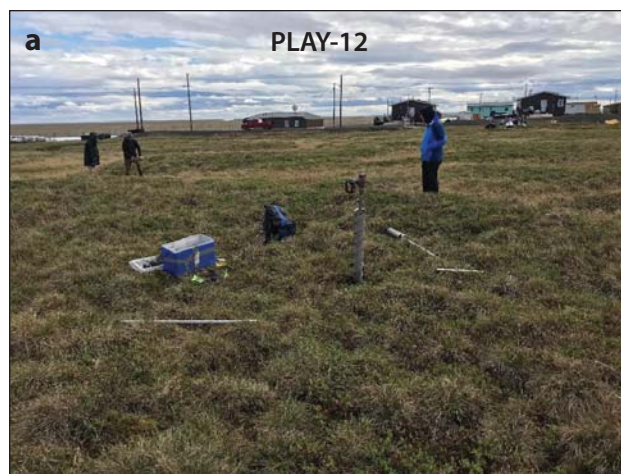
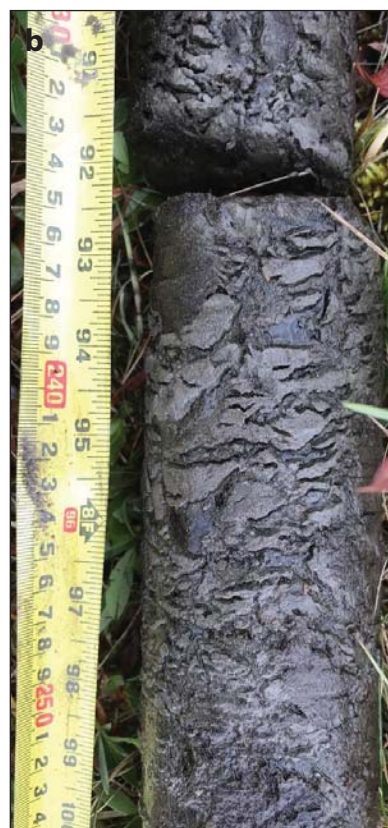
**Figure A1.9. a.** Borehole PLAY-12 at elevation 11.8 m a.s.l. was drilled with a SIPRE corer on a high surface north of the village. **b.** The core sample shows an ice-rich sandy silt with mainly ataxitic cryostructure at a depth of 230-255 cm. (Credit: M. Kanevskiy)

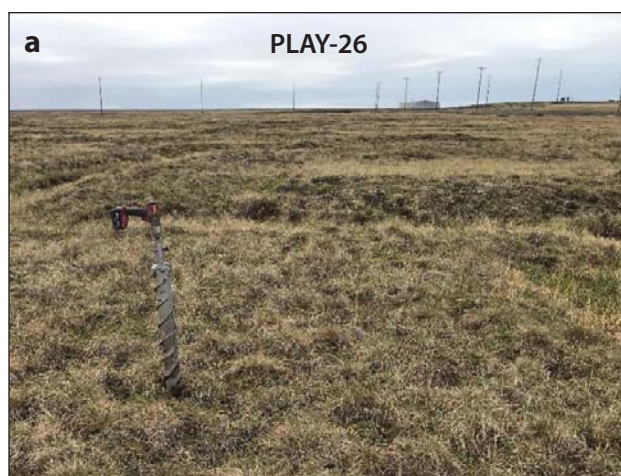
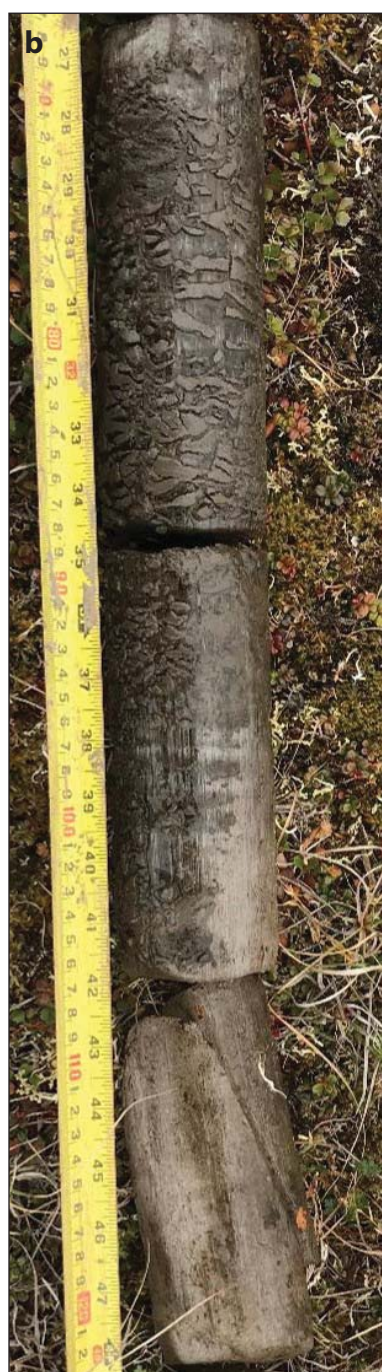
**Figure A1.11. a.** Borehole PLAY-26 at the center of a dry ice-wedge polygon, elevation 3.4 m a.s.l., was drilled with a SIPRE corer to 182 cm and with the Kovacs auger from 182 to 273 cm. **b.** The drilling analysis shows ice-rich silty sand from a depth of 68 cm and a buried ice wedge from 108 cm to 268 cm. (Credit: M. Kanevskiy)

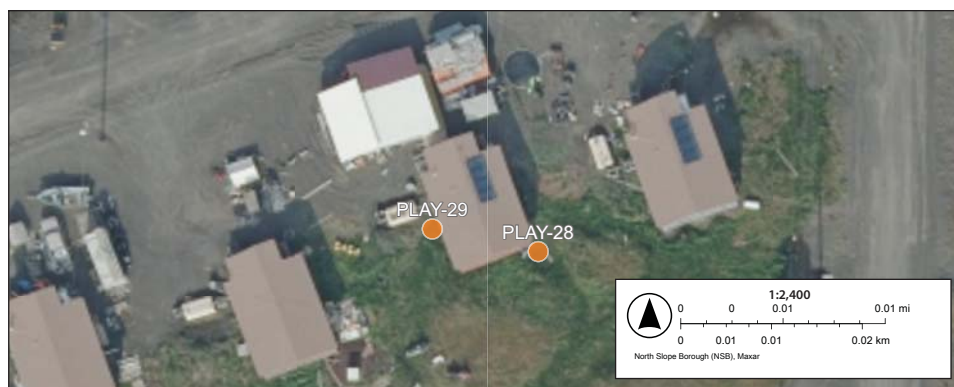
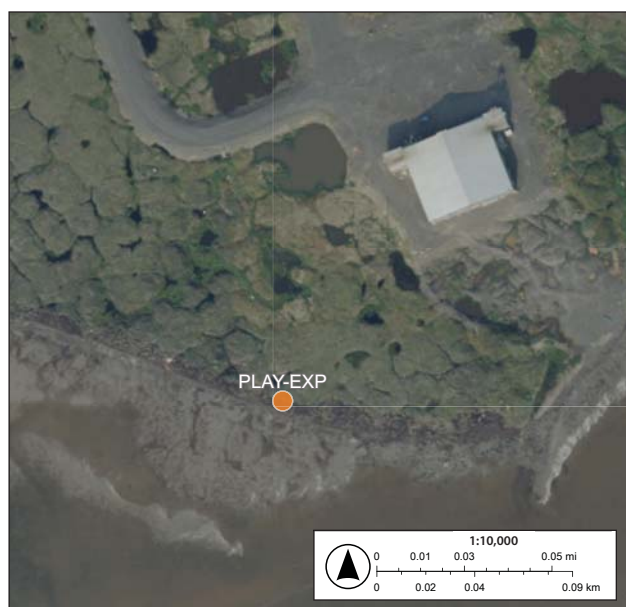
**Figure A1.13.** Permafrost exposure PLAY-EXP with the exposed ice wedge was examined on the bluff south of the airport on 29 June 2022. (See Figure A1.1 for general location map.)

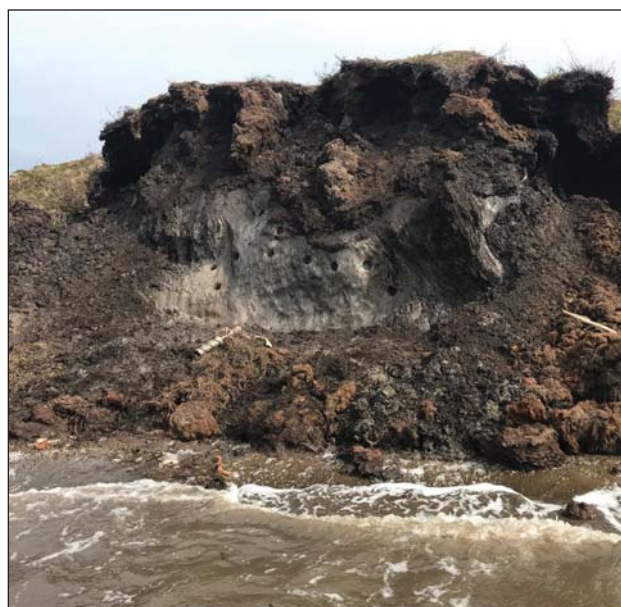
**Figure A1.14.** Sampling locations in the face of the coastal exposure PLAY-EXP to examine exposed wedge ice and adjacent frozen soils in the bluff behind the airport. The height of the bluff was measured at 4.8 m a.s.l. (which corresponds to the lower parts of yedoma slope), exposed part was ~0.6 to 2.8 m a.s.l. Exposed ice wedge ~2 m wide was enclosed in saline ice-rich very fine to fine silty sand with vertical peat inclusions. More likely, this ice wedge extends below sea level. (Credit: Mikhail Kanevskiy)
