Snowmelt and Lake Recharge Monitoring for Selected North Slope, Alaska, Lakes: May/June 2008

North Slope Lakes Hydrologic Modeling Project
Report No. INE/WERC 08.13

Snowmelt and Lake Recharge Monitoring For Selected North Slope, Alaska, Lakes: May/June 2008

Report Number INE/WERC 08.13

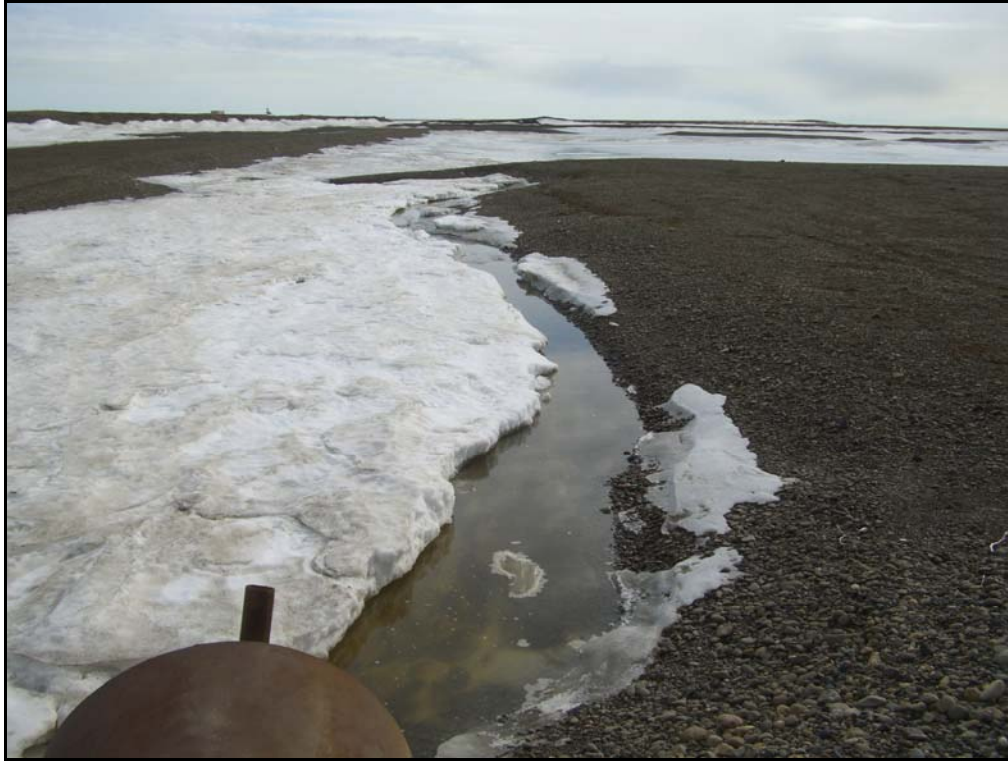
Figure 2. Culvert leading from Kuparuk Deadarm cell 1 into cell 2, photo by C. Cormack.

On 5/26/08 it was observed that ponds had formed near KDA2 and water was running through the culvert from KDA1 to KDA2. About 50% of the snow pack was still present. On 5/27/08, a slight increase in water level was detected at KDA2. On 5/28/08, with about 20% of the snowpack remained, KDA2 and KDA3 were connected and the culvert between KDA1 and KDA2 was full and flow was not visible. There was also low flow from runoff on the south side

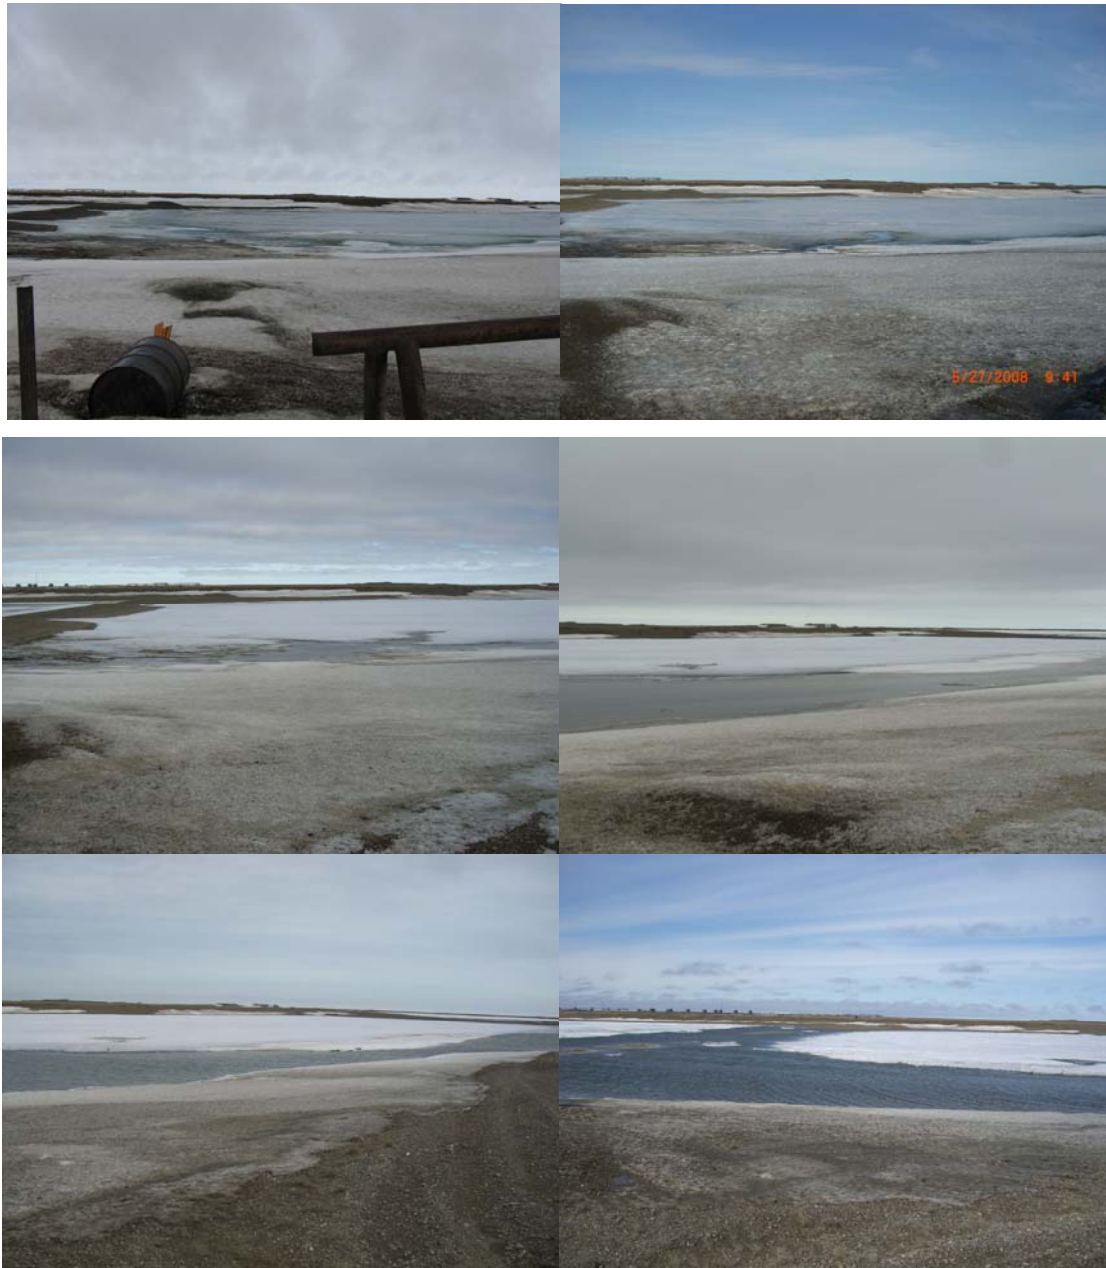
Figure 3. View of KDA 3 from road on 5/25/08, 5/27/08, 5/29/08, 5/31/08, 6/2/08 and 6/3/08.

of KDA4 with the majority of flow directed into the culvert which led to KDA3. By 5/30/08 most of the snow pack had melted. By 5/31/08 water levels had reached their maximum with connections between KDA1, KDA2, and KDA3. On 6/2/08, the connection between KDA1 and KDA2 was underwater, and there was continued flow from KDA3 to KDA4.

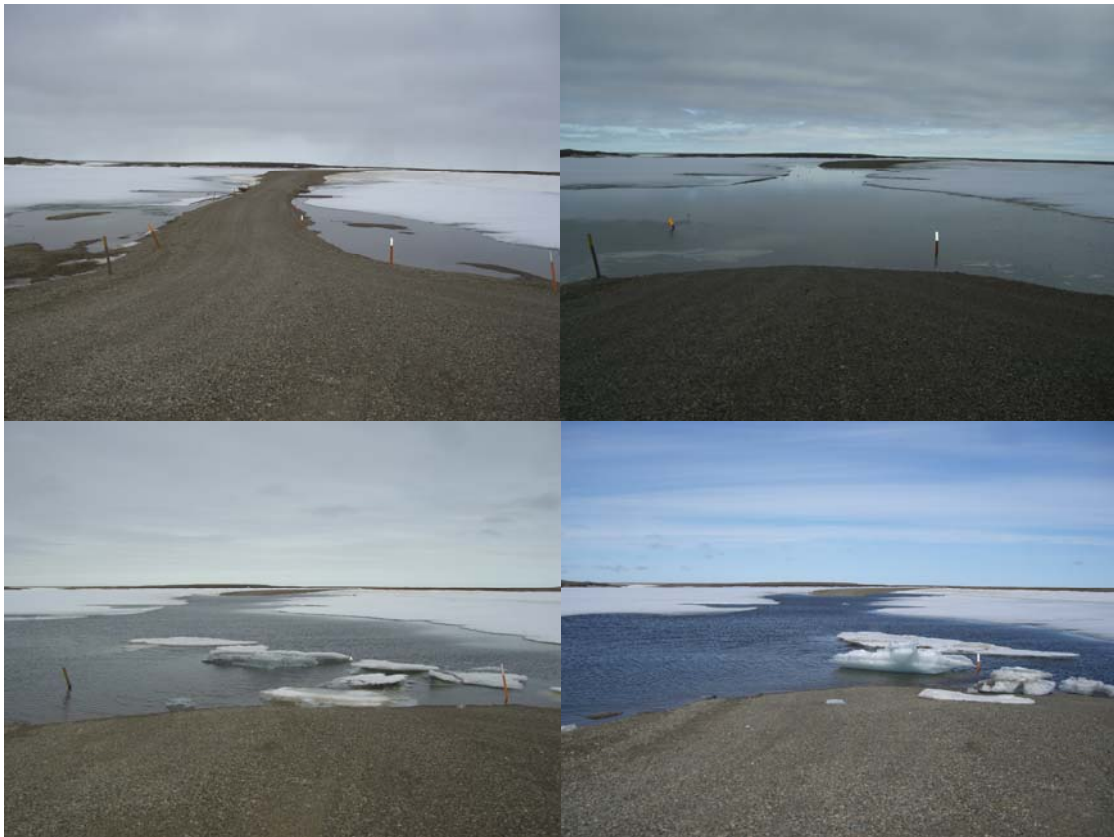
Figure 4. Road between KDA 4 and KDA 5 on 5/28/08, 5/29/08, 5/31/08, and 6/2/08.

Water levels were observed rising in KDA 4 and 5 from snowmelt on 5/24/08. The water levels between KDA 4 and 5 are shown in Figure 4. By 5/31/08 water levels had reached their maximum and started to decline with the following stage of the Kuparuk River (Figure 5). On 6/2/08, it was noted that there was continued flow from KDA3 to KDA4.

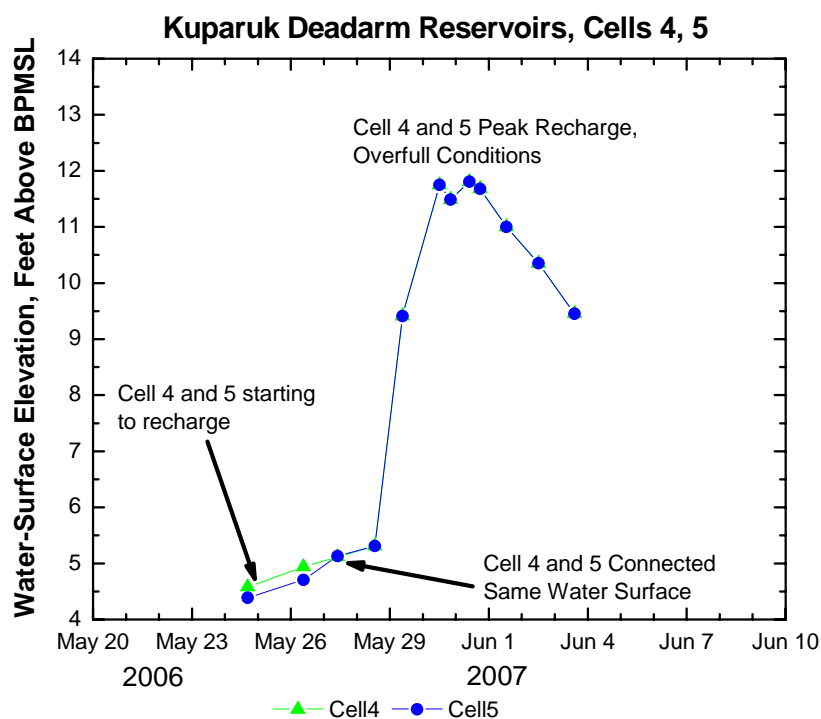
Figure 5. Water level elevations for KDA 4, 5 during snowmelt and Kuparuk River backwater flooding.

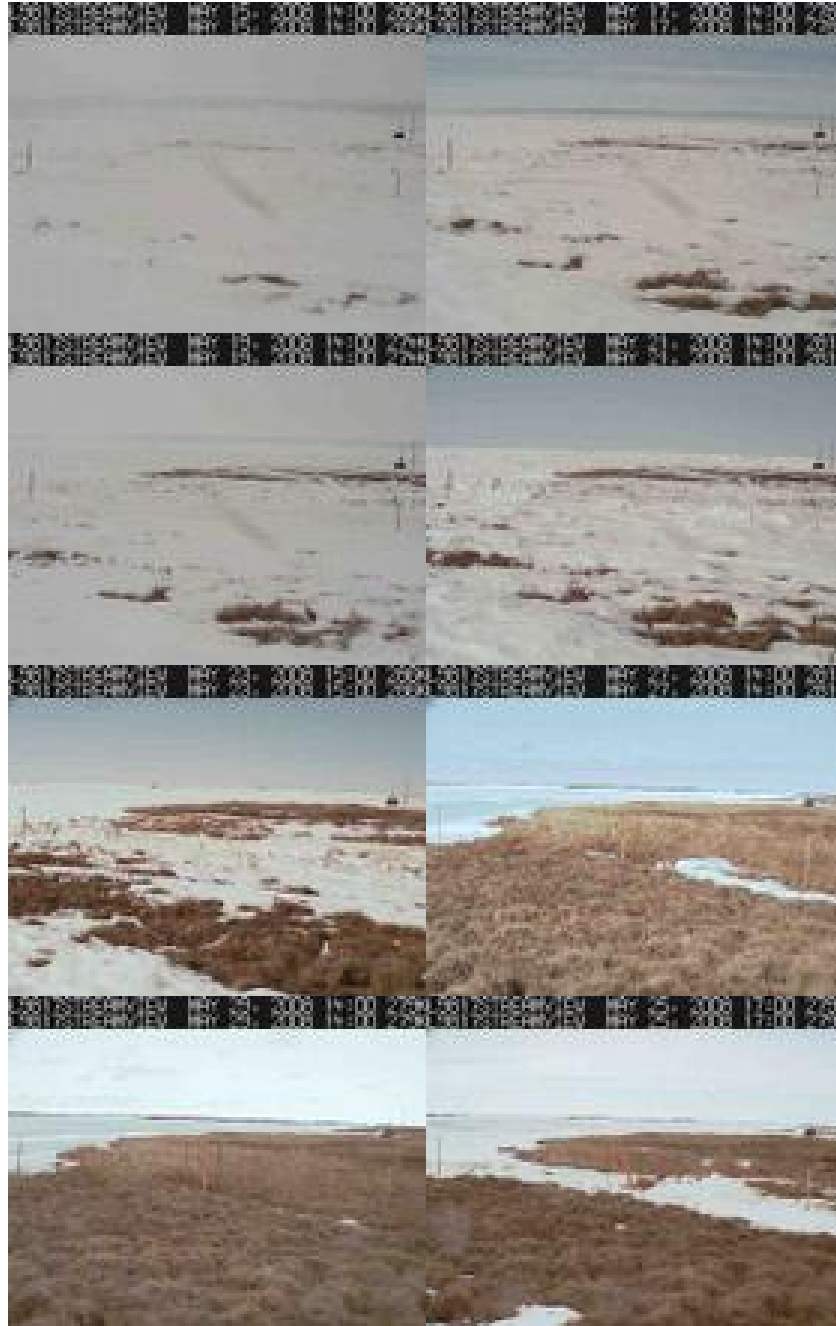
Figure 6. L9817 snowmelt as seen from the met station camera, photos are from every other day between 5/15/08 and 5/29/08.

On 5/17/08 L9817 was visited and it was observed that there was hard packed snow covering about 95% of the site, more than what was seen at L9312, and it appeared as if there was more snow accumulated to the west. By 5/23/08 there had been significant snow melt at the weather station sites (UAFWS1, UAFWS3, UAFWS4), with the greatest amount of snow at UAFWS3. By 5/22/08 a large portion of the snow on the tundra had melted, as noted in the following met station camera photos in figure 5.

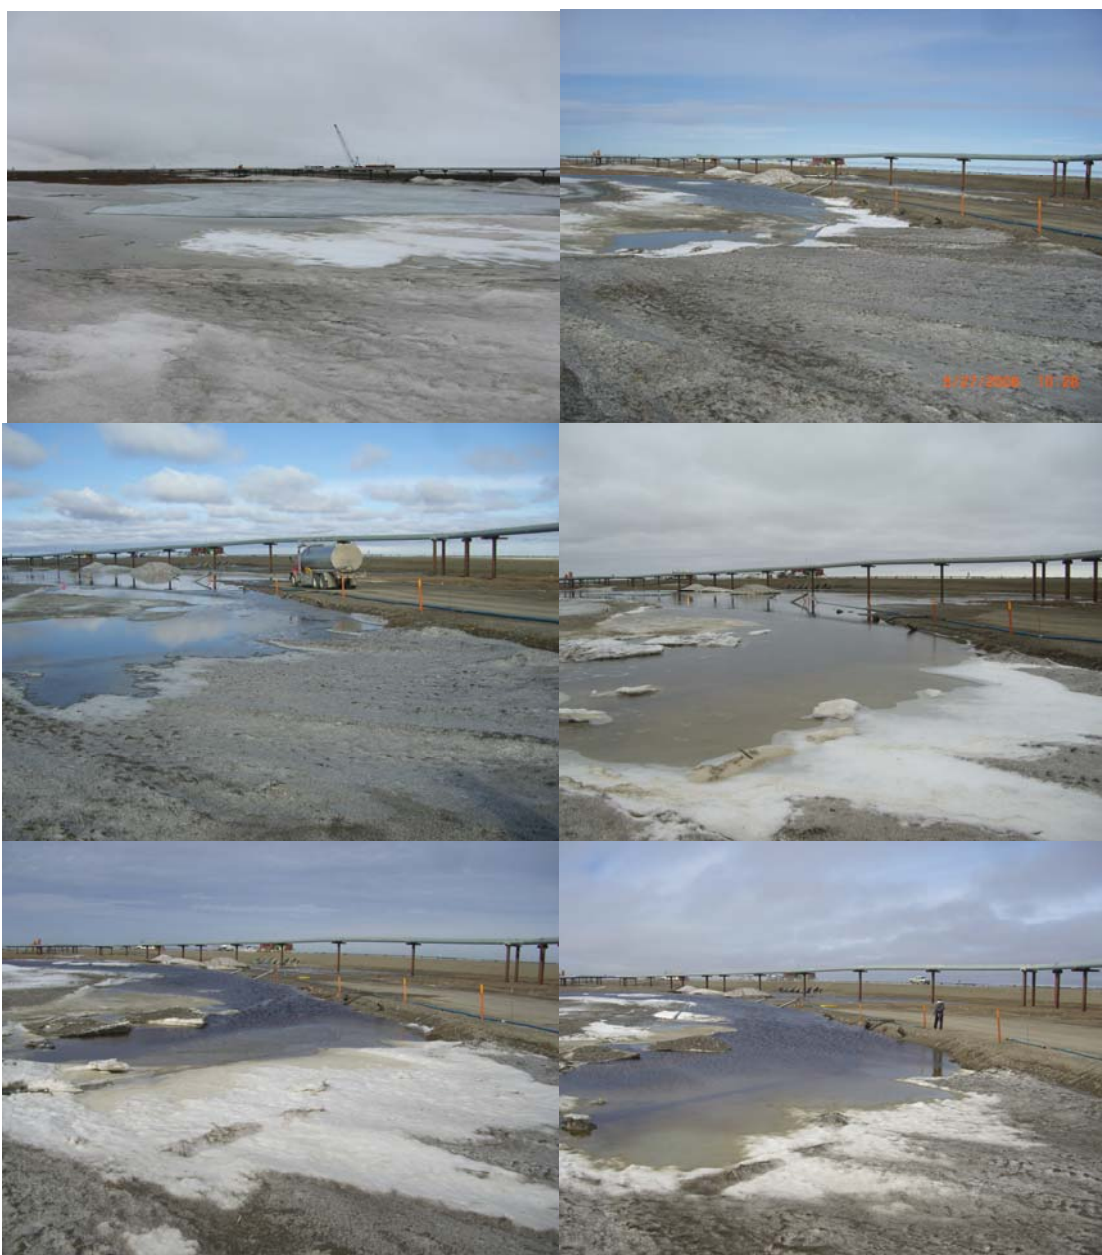
Figure 7. Snowmelt at Mine Site B from weather station on 5/25/08, 5/27/08, 5/29/08, 5/31/08, 6/2/08, and 6/3/08.

On 5/26/08, Milne Creek was flowing, which is the outlet for Mine Site B, and the water levels were up. By the next day the water levels had begun to go down, but snowmelt continued past 6/3/08. On 5/30/08, Mine Site B had reached its highest water mark of 100.45 ft. By 6/1/08, the water mark had dropped a foot to 99.1 ft.

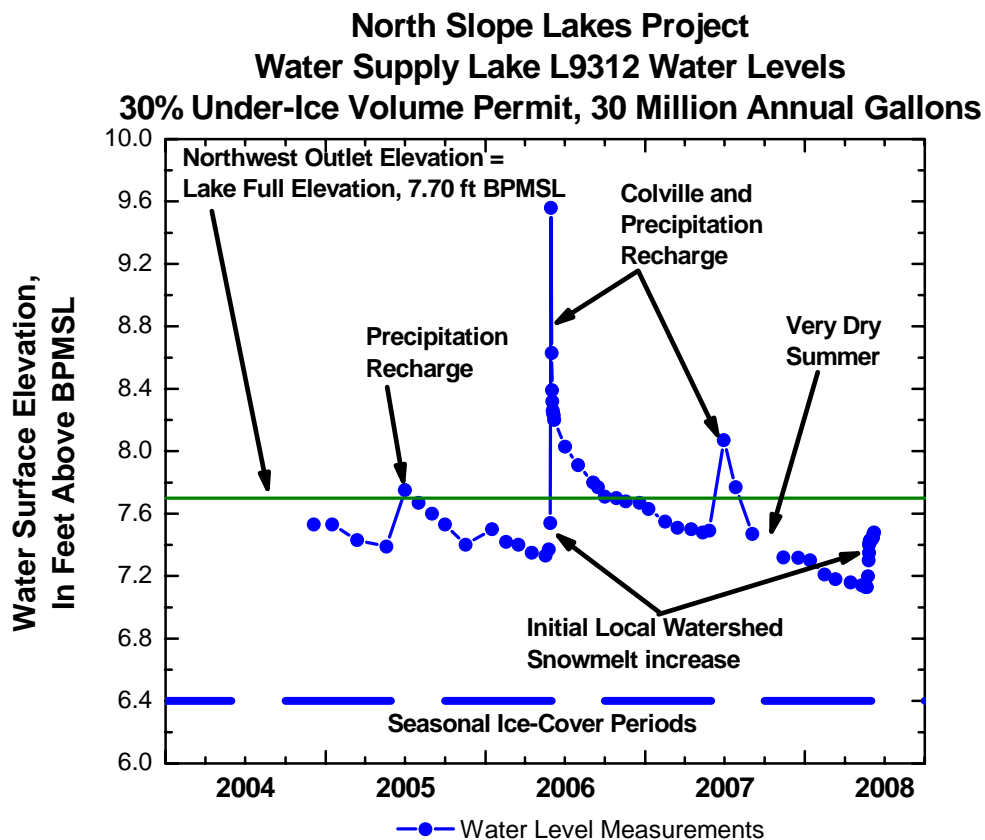
Figure 8. Water levels at L9312. Snowmelt recharge is seen at the end of May 2008

Snowmelt was first observed between 5/15/08 and 5/17/08. By 5/25/08 there was not a lot of snow left at L9312 anywhere and it rained for several hours. The tundra was very wet, the outlet was saturated, and there was water flowing into the lake from several points on the tundra. By 5/29/08 almost all of the snow was melted and snowmelt for this site was nearly complete. Water levels continued to rise into the first week in June (Figure 8).

Snowmelt recharge was observed at L9817 and L9312. L9817 completely filled up to its outlet elevation. L9312 did not fully recharge but came close to its outlet elevation of 7.70 ft above BPMLS on June 7 when it reached an elevation of 7.48 ft. Kugaruk Deadarm Reservoirs were overfilled by both snowmelt and backwater flooding from the Kugaruk River. Mine Site B was also overfilled from snowmelt runoff from East Milne Creek. Lakes and reservoirs that did receive overbank or backwater flooding from streams and rivers were also observed to recharge during early snowmelt. This information is important for permitting agencies as well as industry professionals who depend on water assets for facility use and ice road/pad construction.
